SELWOOD SELTORQUE 150C

Operating & Service Manual

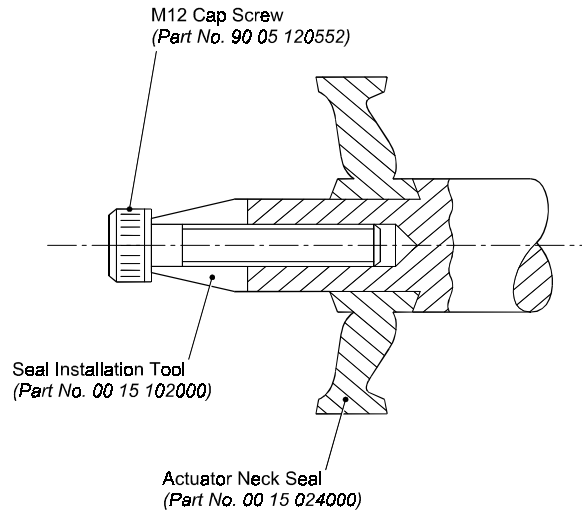
6.2 Fitting of Actuator Neck Seal

1. Lightly clamp seal installation tool against end of drive rod by means of capscrew, as shown.
2. Push seal into rear of inner pump body recess (Part No 0015014000).
3. Clean exposed shaft and tool surfaces, and smear with soft soap. Carefully slide the actuator neck seal onto shaft until it abuts against the conical shoulder.

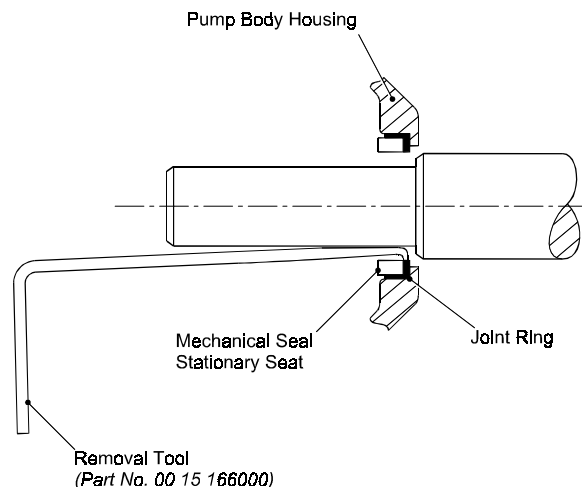
6.3 Removal of Mechanical Seal Stationary Seat and Joint Ring

1. Ensure oil is drained from flushing chamber. Remove impeller and shaft sleeve, complete with rotating mechanical seal components.
2. Engage tip of removal tool on inside face of seat. Remove seat by pulling evenly at several peripheral points.
3. Joint ring can then be collapsed and discarded.
4. To replace, the mechanical seal stationary seat and joint ring must be assembled together with the outer face of the joint ring smeared with soft soap, offered up to the flushing chamber housing and gently pressed home using a piece of wood.

New Mechanical Seal Components must be handled with great care. In particular, the seal faces must not be touched by hand and must only come into contact with clean soft paper that is free from abrasive materials. Premature seal failure is likely to occur if this advice is not heeded.

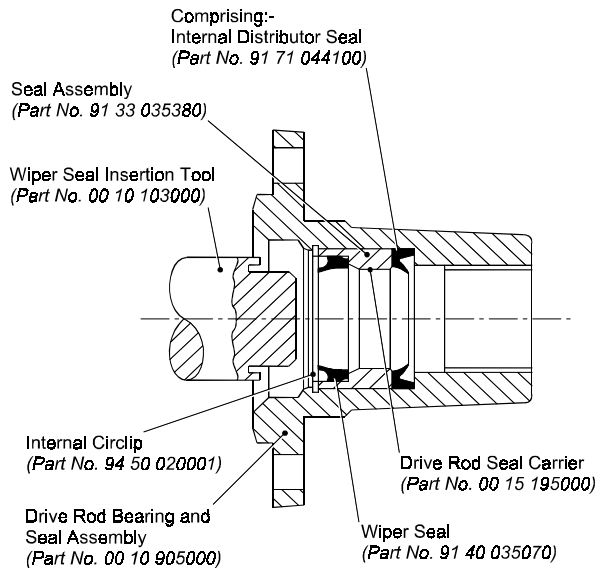
6.4 Removal of Drive Rod Seal Assembly

1. Remove internal circlip with suitable pliers and remove seal assembly by carefully tapping with blunt punch or drift from bush end.
2. Replacement of all components may be aided by smearing adjacent surfaces with soft soap.
3. Prior to sliding home the drive rod seal carrier (Part No. 0015195000), wiper seal (Part No. 9140 035070) **must first** be assembled together, using insertion tool Part No. 0010103000. Carefully applied pressure from a hand press or vice jaws may be employed for this operation.

Parts must be assembled in correct order and orientation.

4. Great care must be exercised when replacing the circlip to ensure that the lip of the wiper seal is not damaged by the handtools used.

- b) Then the internal distributor seal (A33) is offered up to the bearing and seal housing (A24) ensuring again the correct orientation and pushed into place with the drive rod seal carrier (Part No 0015195000) together with wiper seal (A34) and the whole pressed into place with the wiper seal insertion tool (Part No. 0010103000). Care must be exercised when replacing circlip (A26) to ensure that the lip of the wiper seal (A34) is not damaged by the hand tools used. Refer to Section 6.4.

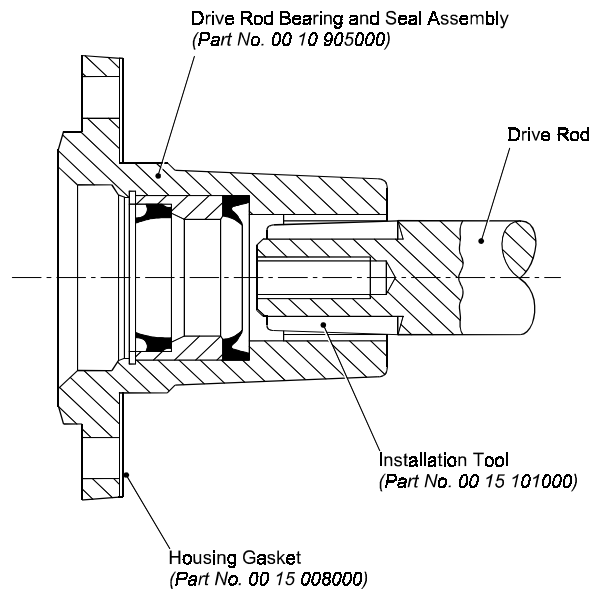
6.5 Fit Seal Housing Sub-Assembly to Pump

1. Thoroughly clean exposed drive rod surfaces and position installation tool as shown.
2. Smear tool and drive rod surfaces with oil.
3. Thoroughly lubricate drive rod bearing and drive rod seal with oil and fit new gasket before pushing seal housing assembly along drive rod until it registers in bearing housing.

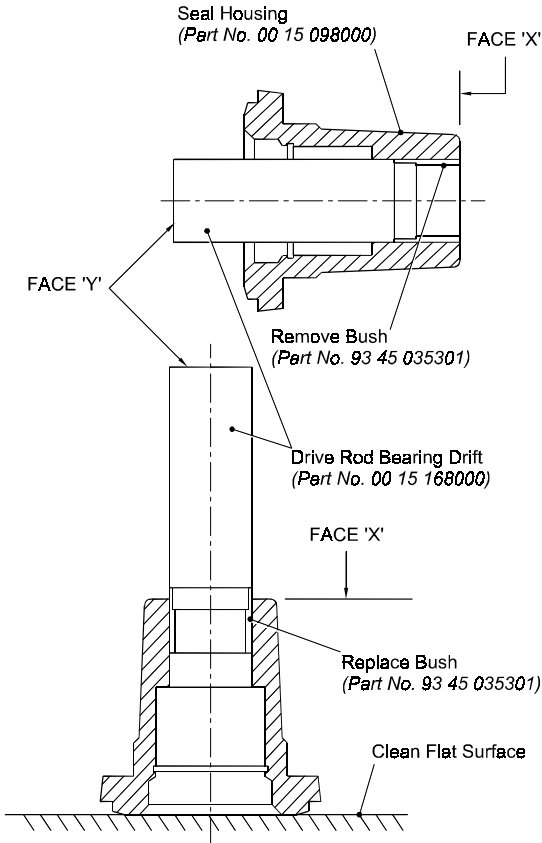
6.6 To Remove Drive Rod Bearing Bush

1. Insert shouldered end of drift into bush as shown in upper sketch.
2. Support air pump pedestal evenly on face 'X' leaving sufficient clearance for bush to emerge freely.
3. Push out bearing bush by pressing or striking on tool face 'Y'.

6.7 To Fit New Drive Rod Bearing Bush

1. Position seal housing on clean flat surface and register new bush in bore as shown in lower drawing.
2. Lightly oil bore and bush to prevent pick up.
3. Insert shouldered end of drift into bush as shown in lower sketch.
4. Insert bush by pressing or striking on tool face 'Y' until end of bearing is flush with face 'X'.

5. To replace drive rod bearing (A28) carefully remove circlip (A26) allowing seal components to be pushed from housing with blunt punch or drift from bush end. The drive rod bush can now be removed using bearing drive (Part No. 001568000) and the new component pressed into position so that one face is flush with the end of the housing.

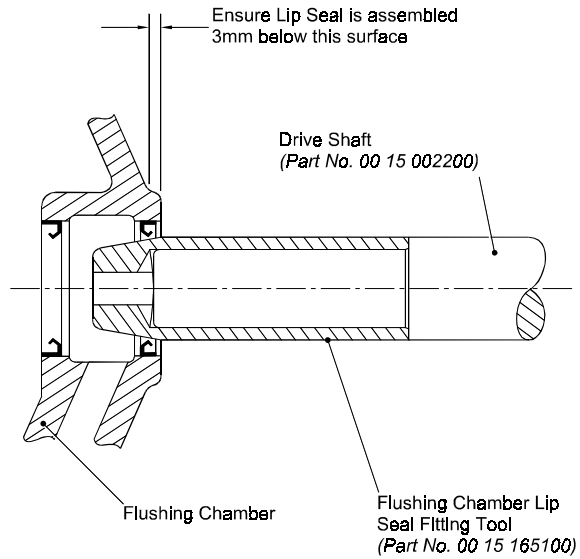
6.8 Assemble Flushing Chamber

1. Check that circlip has been fitted to eccentric, and thoroughly clean exposed shaft surfaces and smear with oil.
2. Check that lip seal fitting tool is internally and externally clean, smear with oil and slide over end of drive shaft as shown.
3. Check that flushing chamber lip seals are correctly orientated and generously lubricate their lips with oil. Slide chamber along fitting tool and onto drive shaft, taking great care to ensure that it remains concentric to the shafts axis.

Lip seals must not be used to support the flushing chamber.

4. Ensure that the lip of the leading seal does not become deformed.

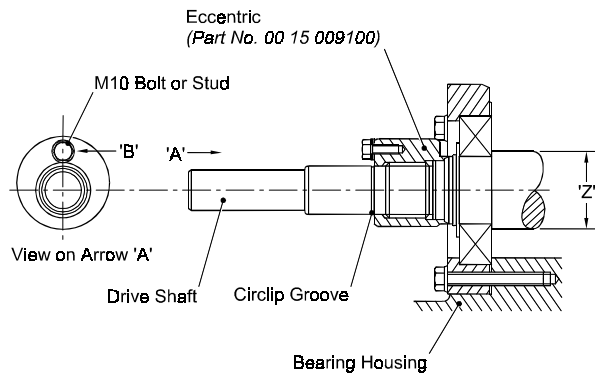
6.9 Remove Eccentric

1. Check that circlip adjacent to eccentric is removed.
2. Insert M10 bolt plus washer into eccentric as shown.
3. To release tap using drift in anticlockwise direction, i.e. in direction of arrow 'B'.

NOTE: If removing eccentric when shaft is disassembled from pump, clamp with soft jaws on diameter 'Z'.

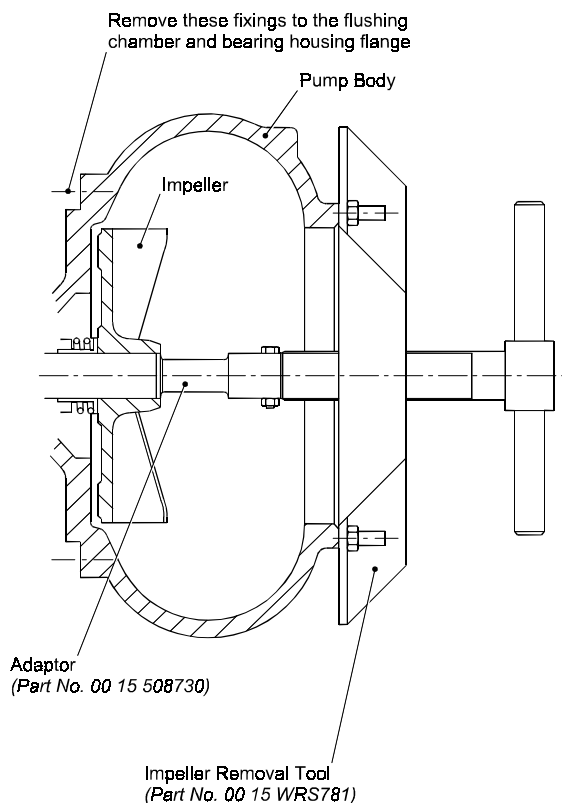
6.10 Remove Impeller

1. Pump should be removed from the chassis or the engine decoupled and the bearing housing supported.
2. Remove suction tube together with separator components ensuring that the gasket between pump body and suction tube is also removed.
3. Remove impeller screw and washers.
4. Remove nuts and washer (8off each) from the studs protruding from the pump body through the flushing chamber and bearing housing flange joint.
5. Offer up impeller removal tool across front face of pump body as shown ensuring the correct nose adaptor is fitted. Affix by using existing nuts and washers.
6. Turn screw handle so that the drive shaft connected to the bearing housing is pushed through and out of the pump body leaving the impeller free.

NOTE: When re assembling impeller ensure end of shaft is coated with Shell ENSIS grease or approved equivalent.

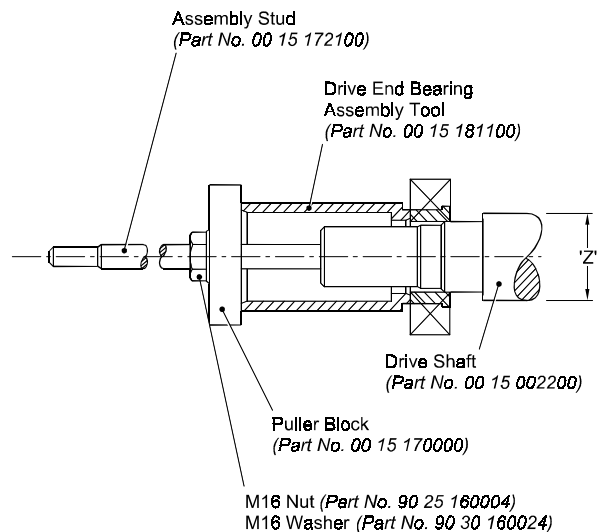
6.11 Fit Replacement Drive End Bearing

1. Remove old bearing taking care not to damage the shaft in any way. Fit soft jaws to vice and clamp shaft horizontally on diameter 'Z' leaving the abutment shoulder overhanging.
2. Screw assembly stud (Part No. 0015172100) into shaft end until it bottoms. Thoroughly clean bearing mounting surfaces of shaft and smear with oil.
3. Carefully register bearing on shaft, ensuring that it is **NOT** contaminated by foreign matter, and position assembly tool (Part No. 0015181100) and puller block (Part No. 0015170000) as shown.
4. Ensuring that the bearing is square to the shaft and that assembly tool is concentric to the shaft's centre line, push bearing onto shaft by applying steady and continuous screwing torque to the M16 nut and washer.
5. Check that inner ring of bearing is touching abutment shoulder of drive shaft:

NOTE: Bearings may be replaced by using the assembly tool in conjunction with a press only, thus eliminating stud and puller block.

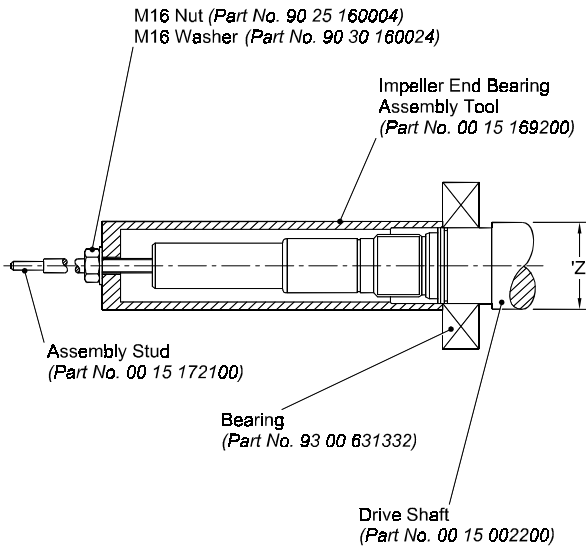
6.12 Fit Replacement Impeller End Bearing

1. Remove old bearing taking care not to damage the shaft in any way. Fit soft jaws to vice and clamp shaft horizontally on diameter 'Z' leaving the abutment shoulder overhanging.
2. Screw assembly stud (Part No. 0015172100) into shaft end until it bottoms. Thoroughly clean bearing mounting surfaces of shaft and smear with oil.
3. Carefully register bearing on shaft ensuring that it is **not contaminated by foreign matter** and position assembly tool (Part No. 0015169200) as shown.
4. Ensuring that the bearing is square to the shaft and that assembly tool is concentric to the shaft centre line, push bearing onto shaft by applying steady and continuous screwing torque to the M16 nut and washer.
5. Check that inner ring of bearing is touching abutment shoulder of drive shaft.
6. Replace the bearing spacer and circlip.

NOTE: Bearings may be replaced by using the assembly tools in conjunction with a press only, thus eliminating stud and puller block.

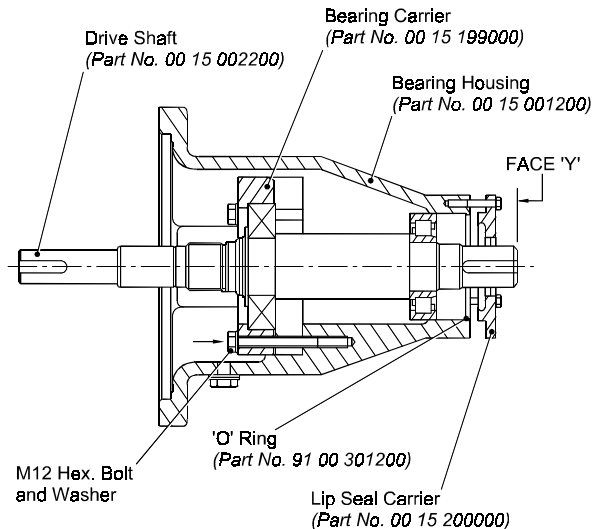
6.13 Assembly of Drive Shaft with Bearings into Housing

1. Remove assembly by releasing the 4 x M12 fixings. The bearing carrier can be jacked free by the two screwed holes adjacent to the fixings. Remove the lip seal carrier (ensuring seal is not dragged over sharp edge of keyway) together with 'O' ring and press or strike (with soft faced mallet) shaft end 'Y', to withdraw bearings and bearing carrier.

4. Position bearing housing in vertical attitude with bell end upwards mounted on suitable supports so that end of shaft can emerge through bottom.
5. Ensure shaft with bearings is inserted into the bearing housing so that it is concentric and parallel to the mating surfaces. Assembly is 'jacked' home by tightening the M12 fixings assembled together with the bearing carrier.

6. Finally ensure lip seal is in good condition together with 'O' ring before finally bolting up the carrier.

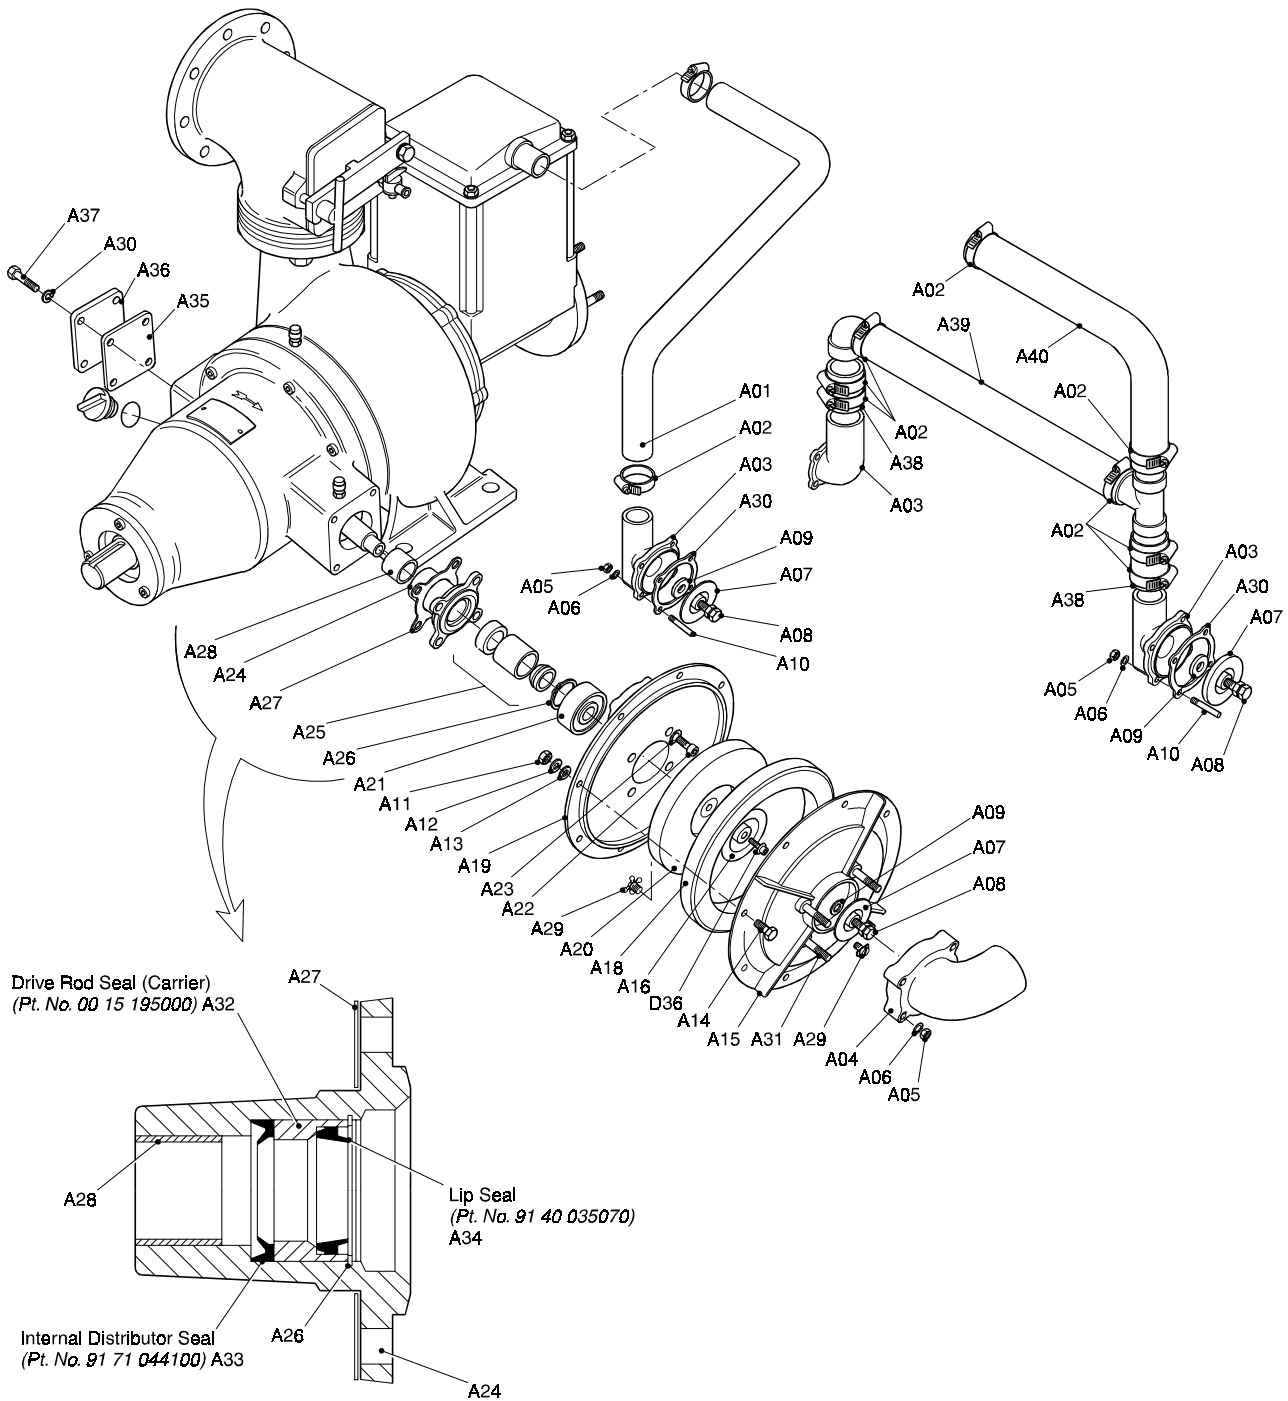
1. Complete assembly available as Part No. 00109050013.
2. Linear Bearing and Seal Assembly Part Nos. 0015195000, 9140035070 and 9171044100 available as sub-assembly Part No. 9133035380.
3. Ensure that seal components are positioned as shown above, and are retained by the internal circlip. Great care must be exercised when fitting the circlip to ensure that the lip of the wiper seal is not damaged by the hand tools used. Refer to Section 5.3 Impeller, Mechanical Seal and Delivery Valve Maintenance.
4. To safeguard the sealing lips, lubricate the bearing and seals with light oil and use seal installation tool when fitting assembled housing unit to pump assembly. Refer to Section 5.4 Maintenance of Flushing Chamber, Air Pump Mechanism, Drive Coupling, Drive Shaft Bearings and Lip Seal.

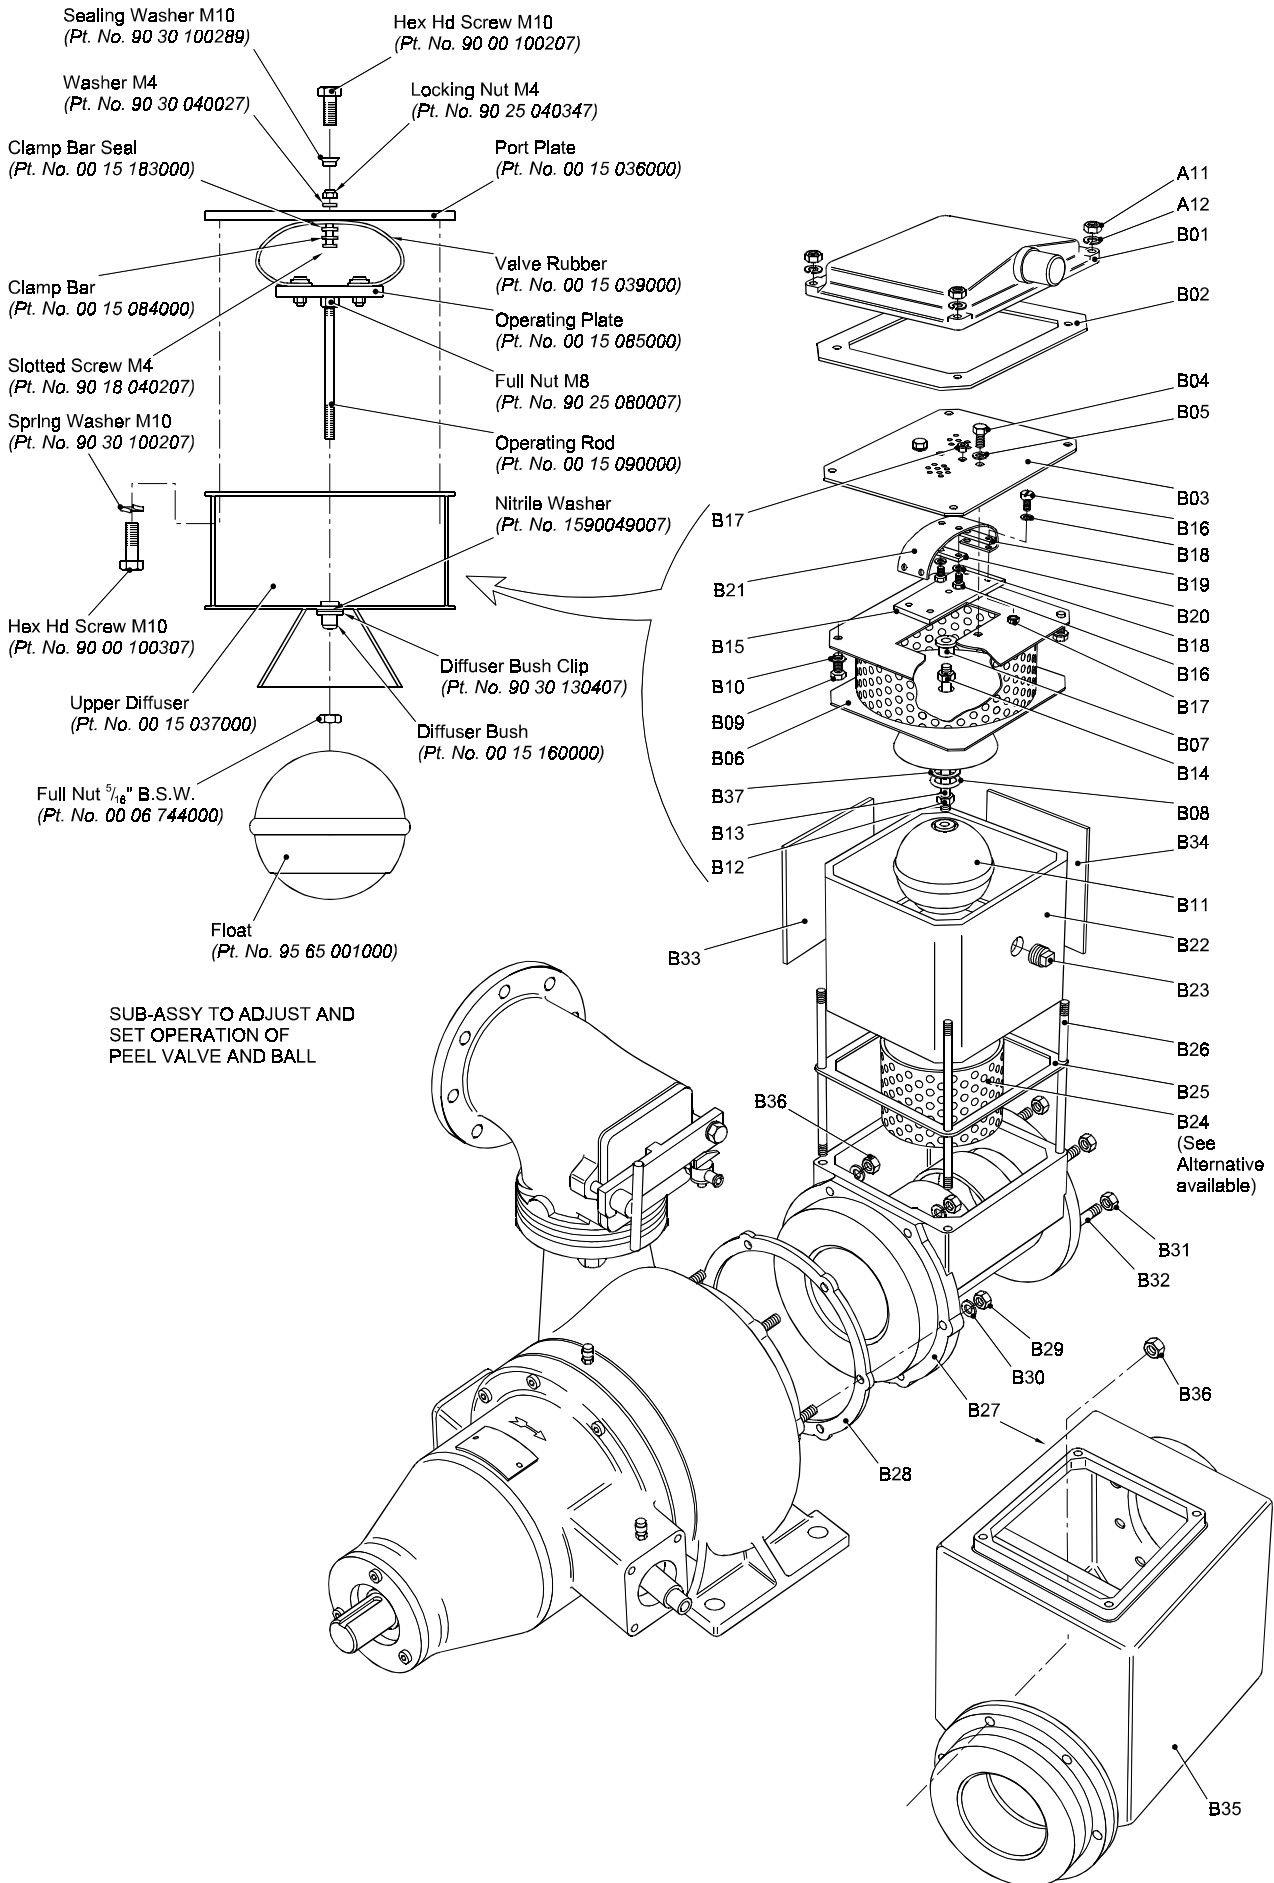
8.2 Separator Parts

SUB-ASSY TO ADJUST AND SET OPERATION OF PEEL VALVE AND BALL
